FEBRUARY 2017

OLSSON PROJECT NO. 016-1500

PLATTE REPUBLICAN DIVERSION PROJECT FEASIBILITY REVIEW

PREPARED FOR:

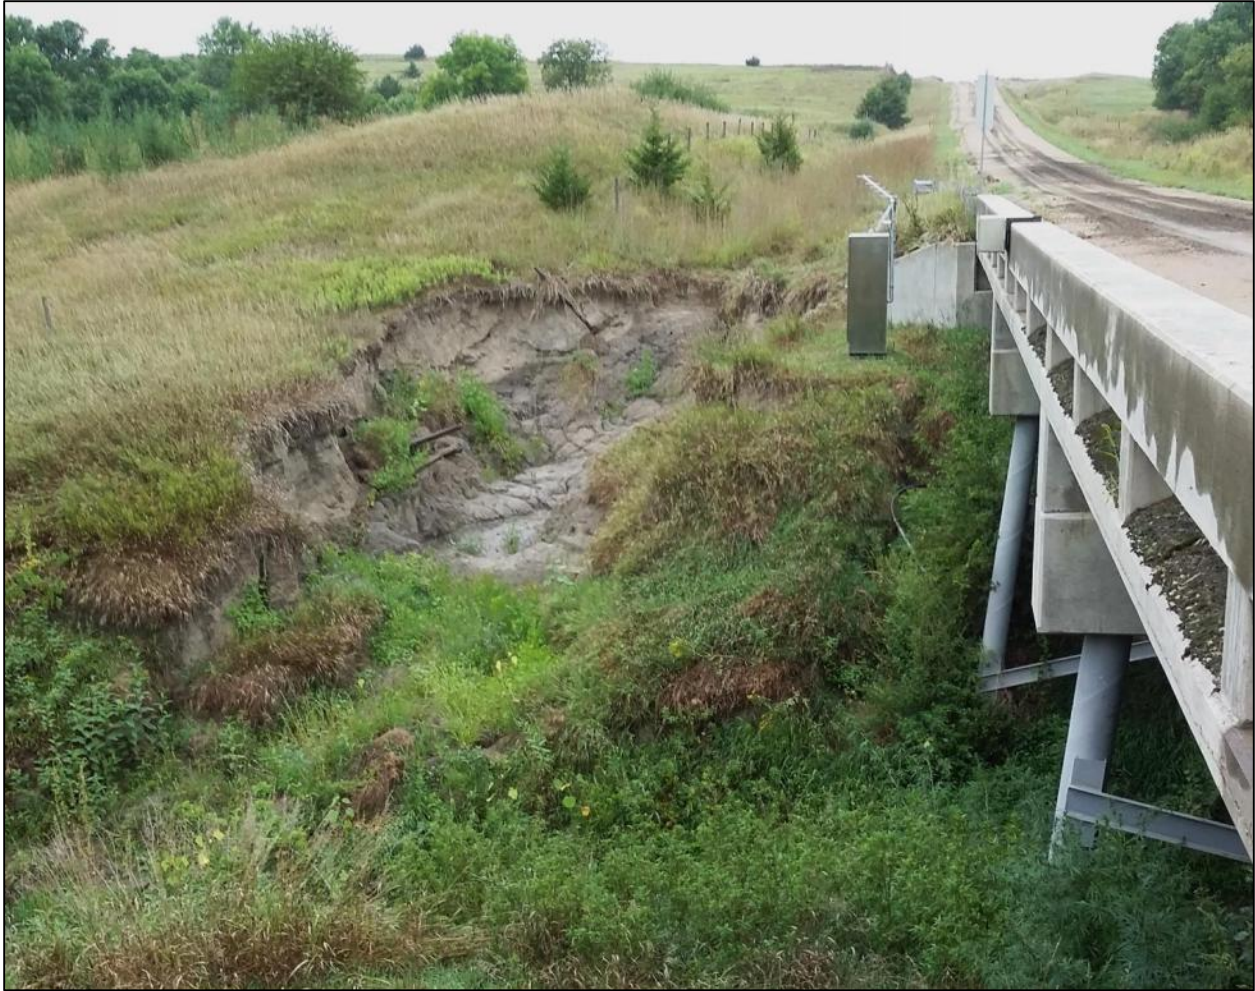
Figure 9. View west showing saturation slump threatening gage at Rd 726.

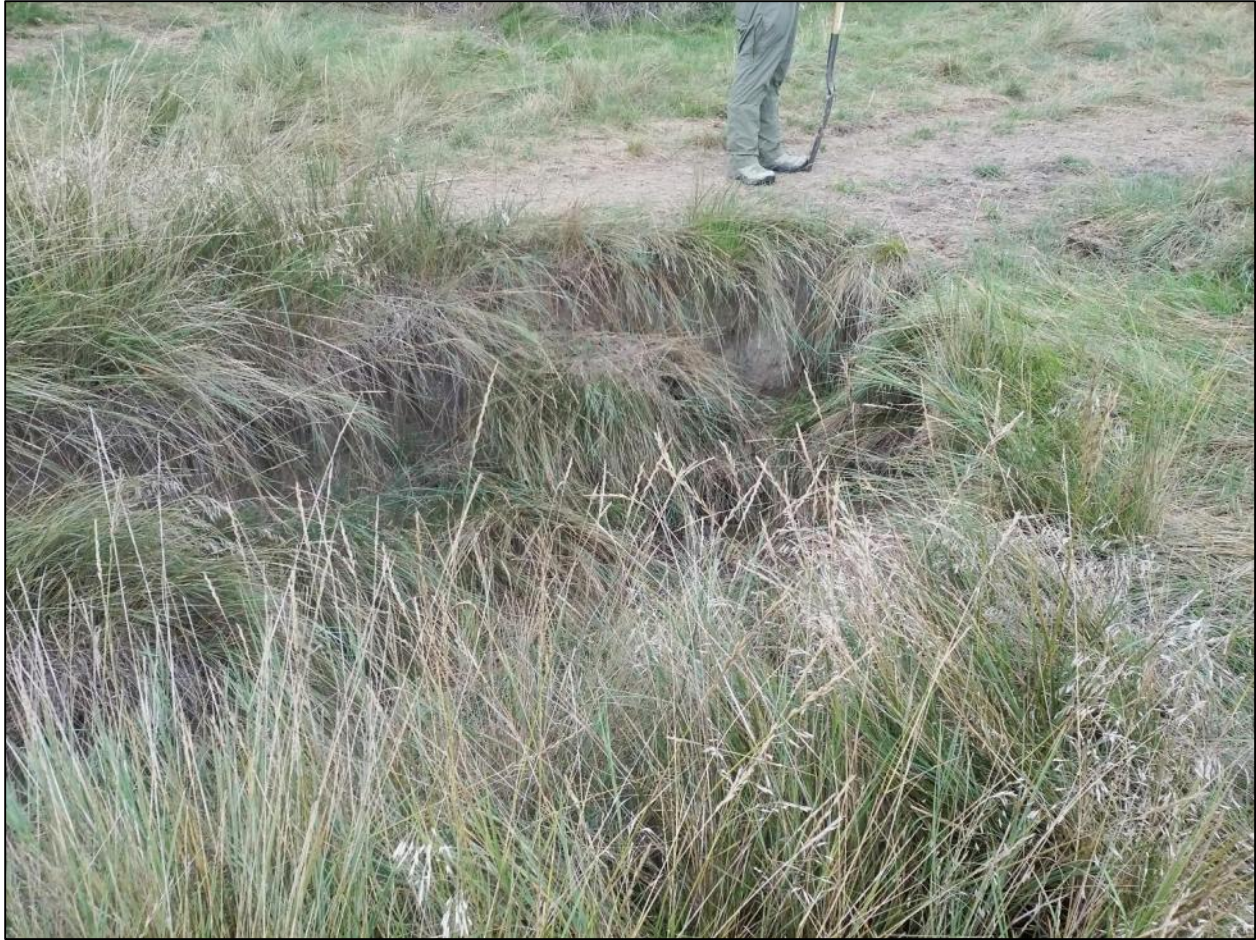
Figure 27. View of 3-4 ft high headcut at upstream end of entrenched channel section 3,000 feet below diversion point.

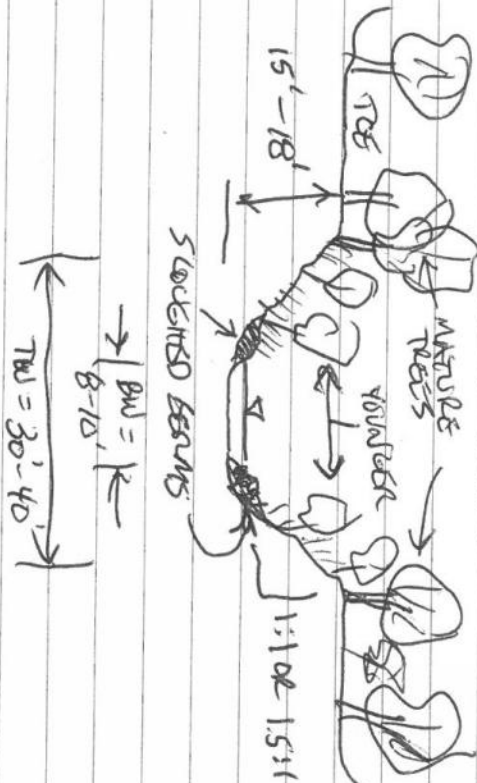
- OCCASIONAL BANK FAILURES w/ TREES
- VERTICAL FACES ON BANKS IN SOME PLACES
