FEBRUARY 2017

OLSSON PROJECT NO. 016-1500

PLATTE REPUBLICAN DIVERSION PROJECT FEASIBILITY REVIEW

PREPARED FOR:

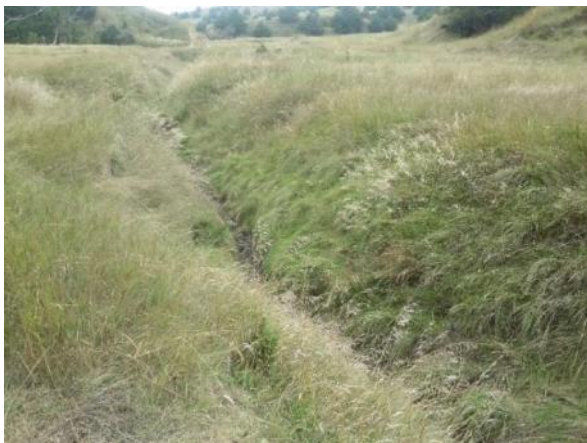
Middle Section of Project Area.

The middle section consists of approximately the next 5 miles of eastern branch of Turkey Creek. It has a defined channel, but has a more limited capacity and is generally steeper relative to the lower section. This middle section has a general top of bank capacity of ranging from 100 cfs at the beginning of the section to 650 cfs just north of Drive 432A. The capacity slowly increases as you progress downstream.

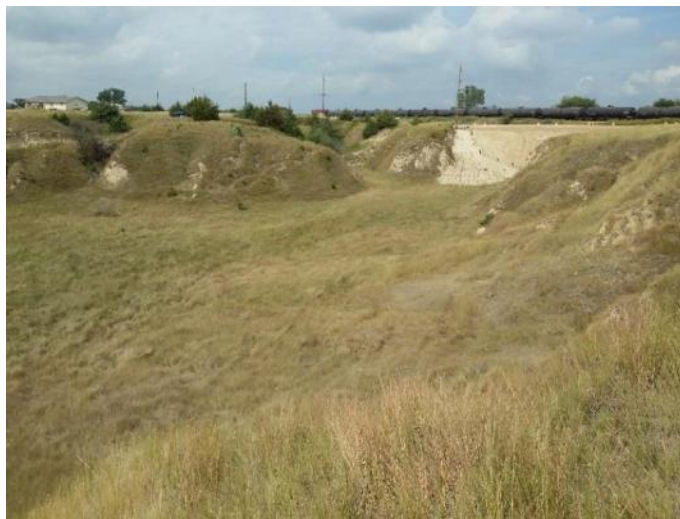
Upper Section of Project Area.

The upper section consists of the first 3,000 feet of eastern branch of Turkey Creek. It has a fairly steep slope for the entire length, which will generate higher velocities during flow events, significantly increasing the potential for erosion. It has a fairly defined centerline however lacks a channel bed, banks, and cross-sectional area to contain flows. Any runoff generated by rainfall events flows overland as sheet flow through this area. With no defined channel the flow is not contained and the upper section has an existing capacity of zero (0) cubic feet per second (cfs).

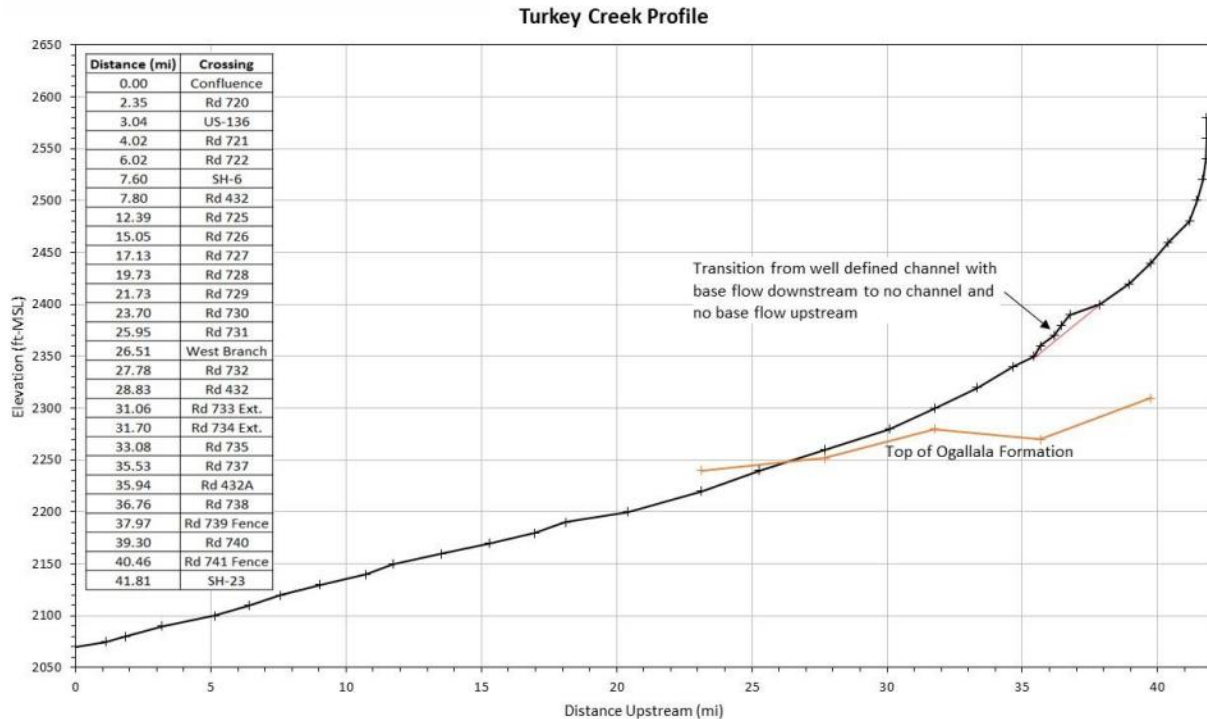
The contour data was also used to produce a profile of the creek and identify any locations with major profile changes that may be impacted by the augmented flows. **Figure 4** shows the profile of the creek using USGS topographic map contour data. The profile is concave, which is typical of most streams. However, a major convexity in the profile occurs between Mile 35.44 and Mile 37.85. This convexity marks the transition of the channel from well-defined to poorly-defined as described above. Figure 4 also shows the approximate location of where the Ogallala Formation daylight in the valley as described in the geology section above.

Figure 4. Topographic profile of Turkey Creek from USGS topographic maps.

The gradient of the channel between contours from Mile 0 to Mile 33 ranges generally between 0.1% and 0.2% as shown in **Figure 5**. However, the convexity in the channel profile between Mile 35.44 and Mile 37.85 (see Figure 4) is also defined by steeper channel gradients as high as 0.79%. It is likely that this steeper reach will need to be stabilized prior to the passage of diverted flows into the creek.

The primary areas of concern are the reach between Rd 737 and Farm Road (Rd 738), which is the steep reach that creates the convexity in the channel profile seen in Figure 4, and the remaining reaches upstream. The steep reach between Rd 737 and Farm Road (Rd 738) should be further evaluated to determine if the profile anomaly does indeed exist, and if so, what the long term effects of the additional flows on the stability of the channel would be in this reach. If the Rd 737 and Farm Road (Rd 738) reach is significantly steeper, the use of stabilization measures should be considered for the reach.

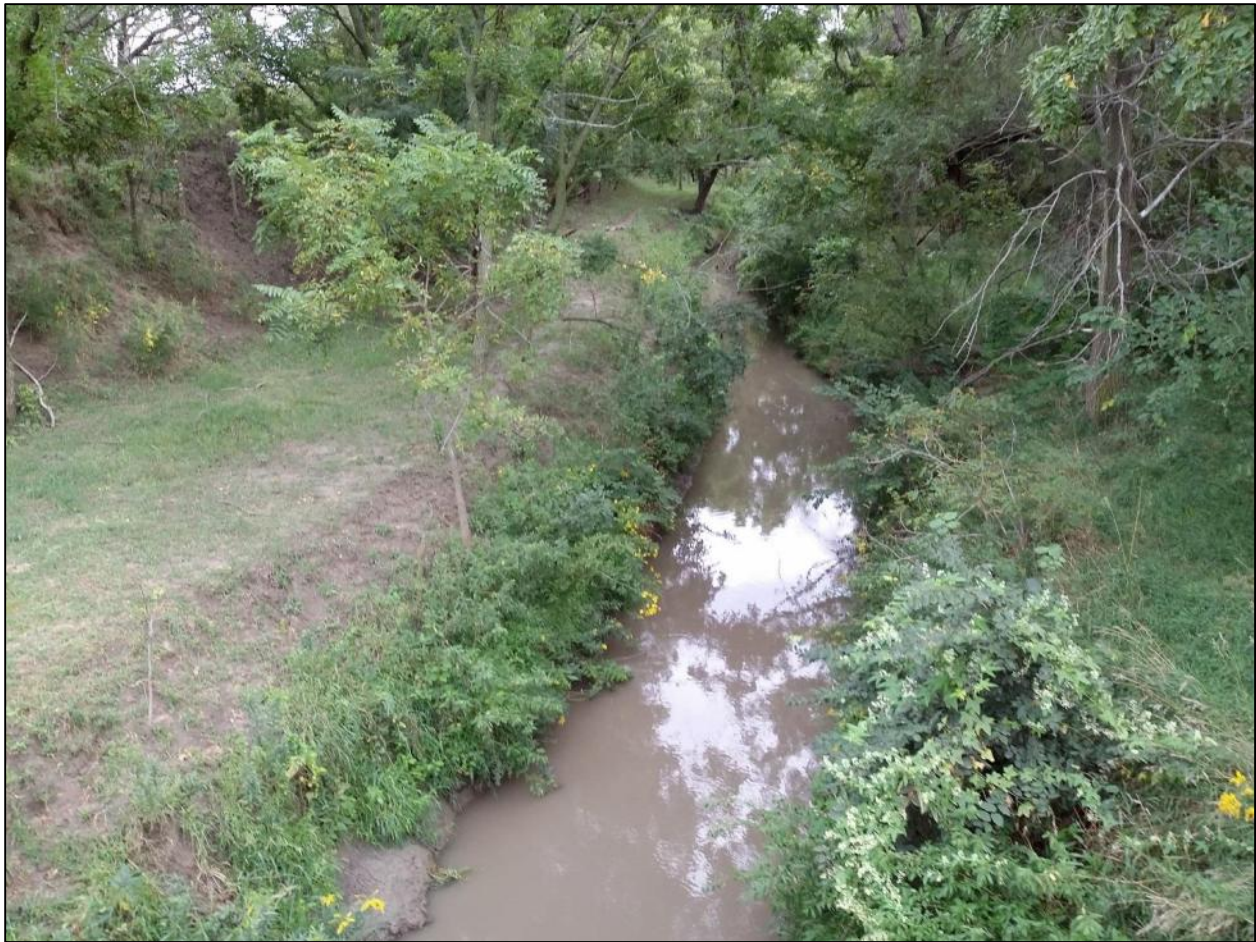
channelization work. **Figure 7** shows the inset floodplain and channel upstream of Rd 720. As seen in the figure, bank erosion does occur in the reach, but it is very slow and the channel has adequate capacity to pass the additional flows.

Figure 7. View looking upstream from Rd 720 bridge.

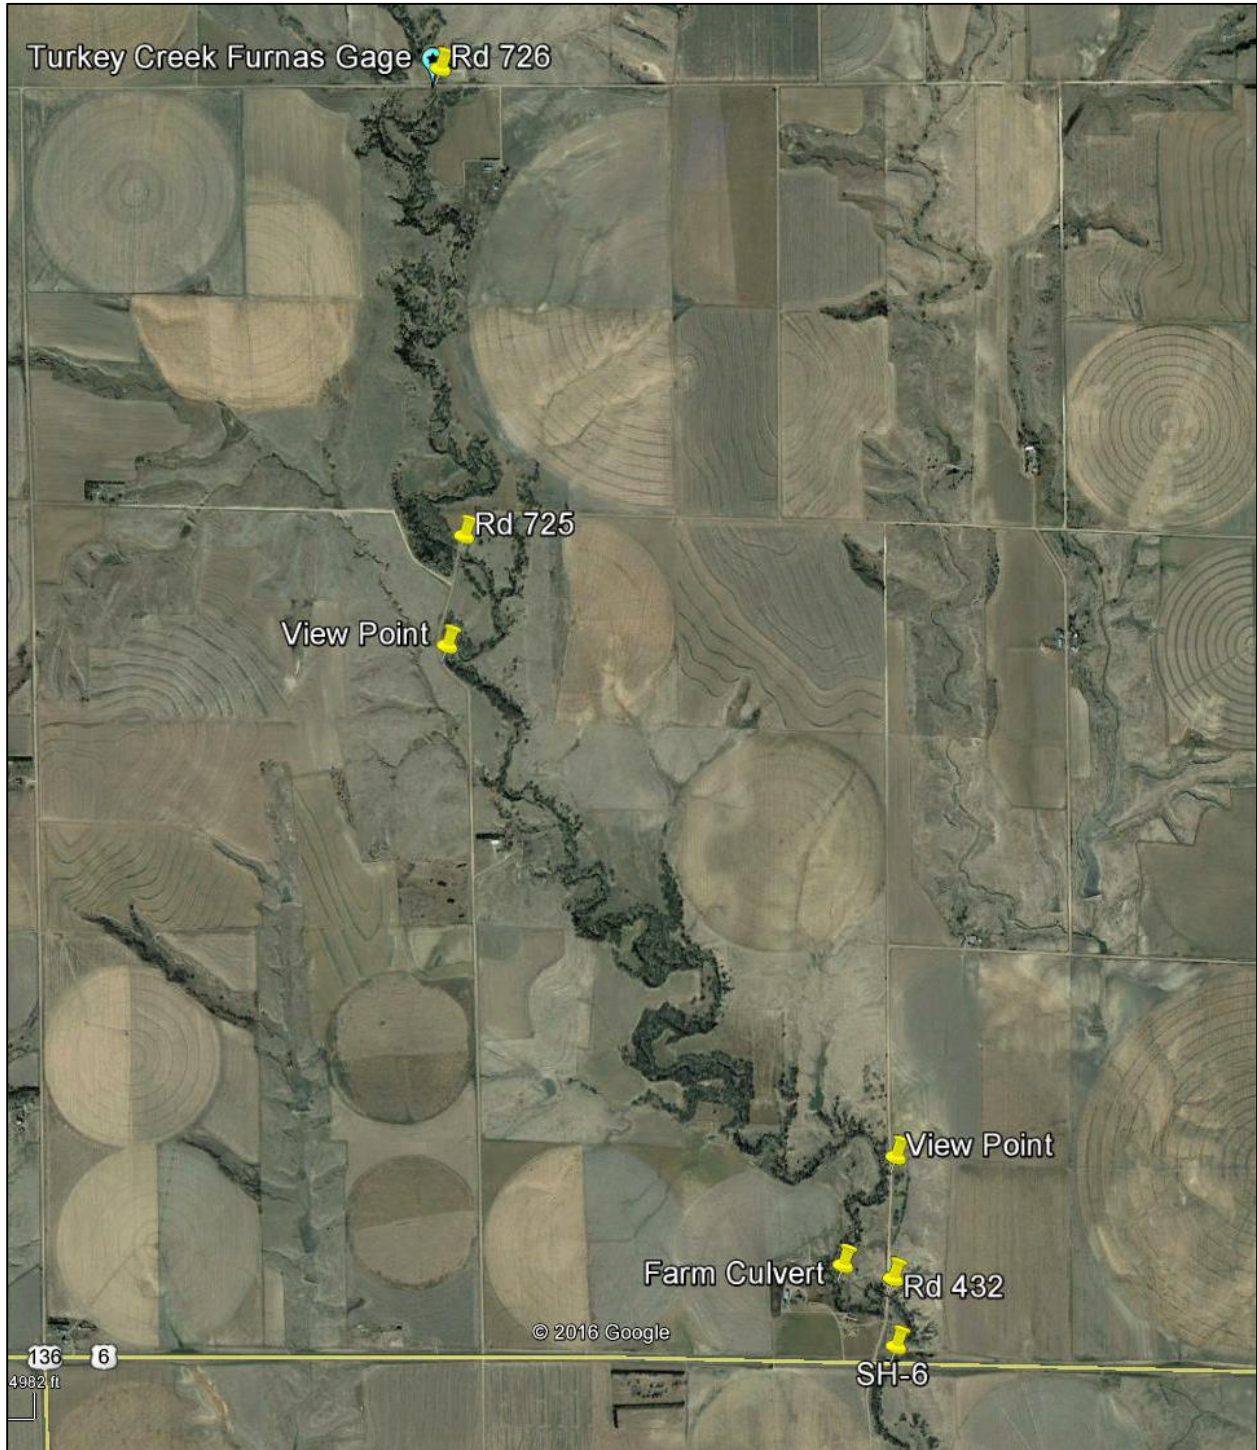
debris in the channel. The channel capacity upstream of the bridge appears to be less than downstream, but the bridge and channel are still capable of passing the additional flows. Upstream and west of the Rd 432 crossing is a farm road crossing with a 48-inch CMP. It is unlikely this culvert will be able to pass the additional flows.

Figure 8. SH-6 to Rd 726 reach.

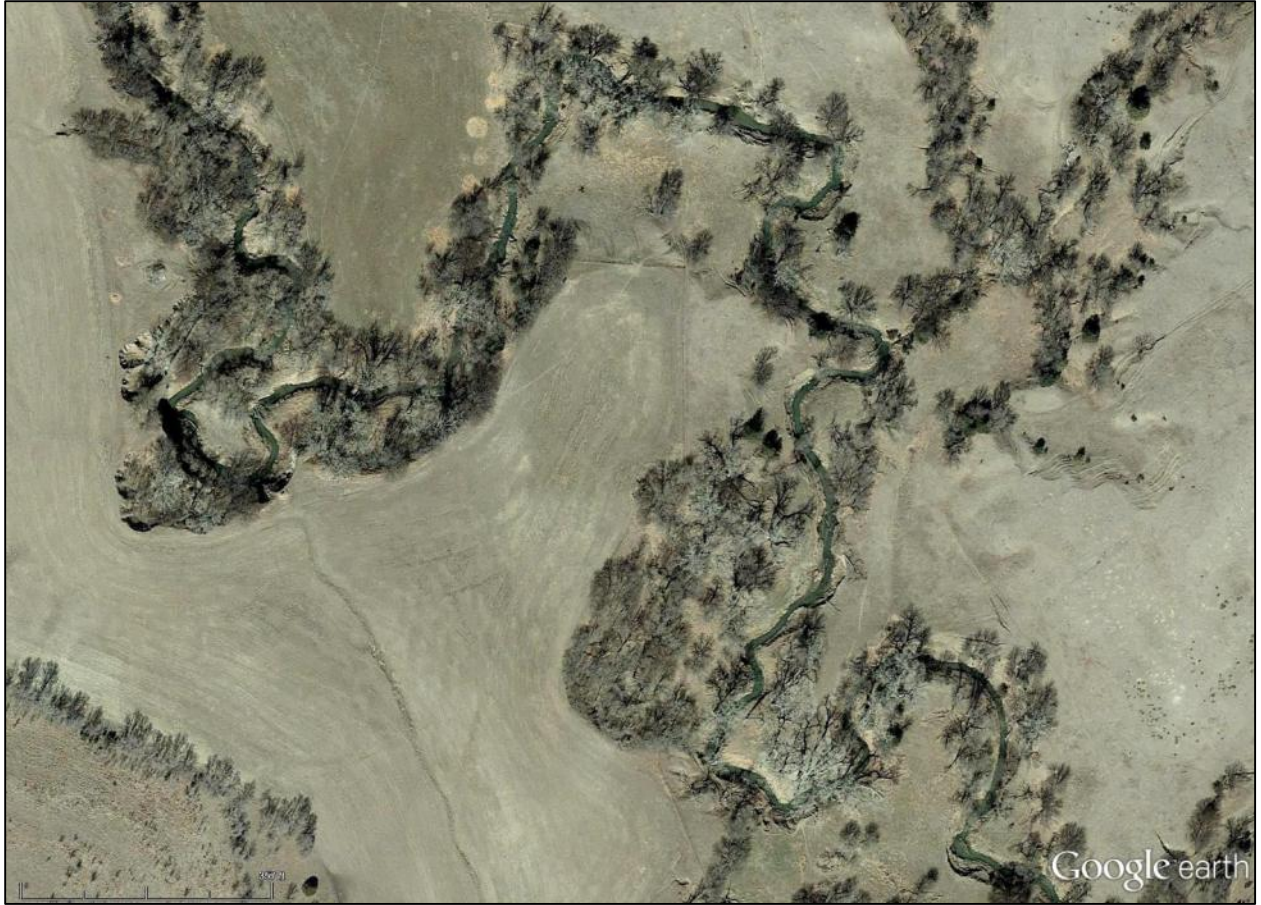
Between Rd 726 and Rd 727 the channel is still fairly sinuous with short segments of tortuous meandering. Bank erosion and bank failures occur occasionally, especially on the outside of meander bends, and low terraces/benches are also present in many of meander bends as seen in **Figure 11**. Fallen trees that pop out large sections of the banks create many of the erosional scallops and pockets in the banks.

Figure 11. View of tortuous meander bends in the creek between Rd 726 and Rd 727.

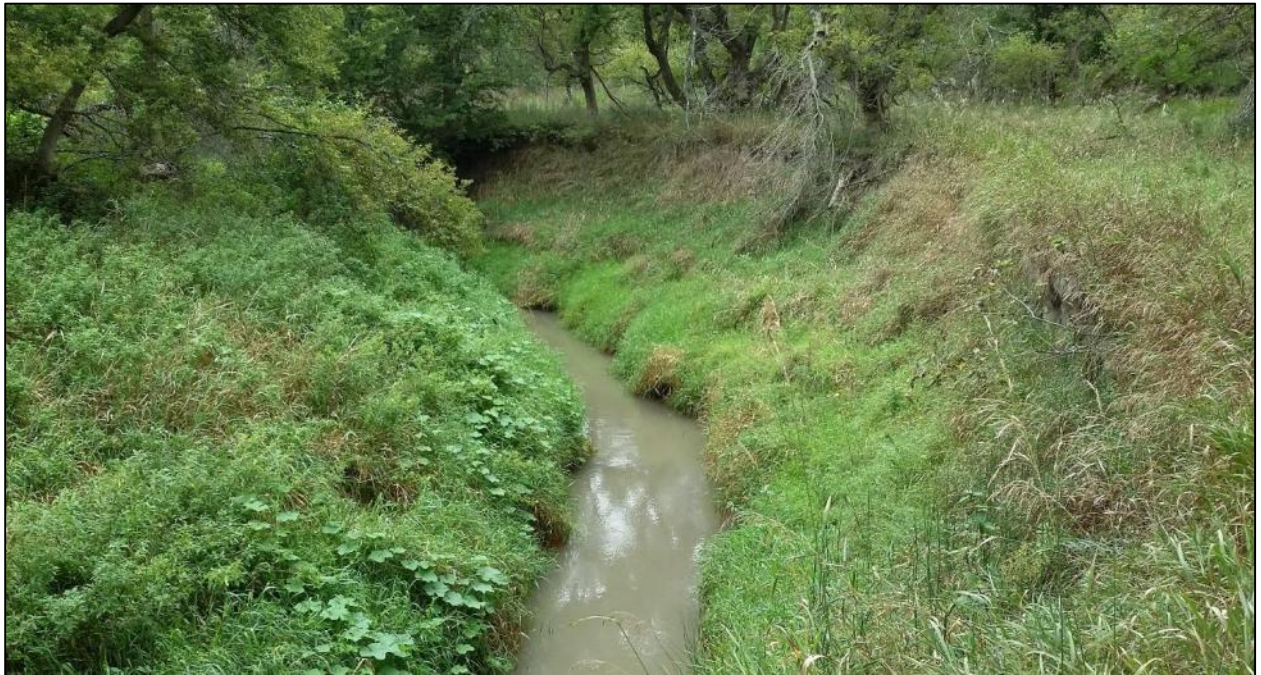
Rd 729 has no bridge crossing, but comes sufficiently close to the creek to allow for observation of the area. The area is very sinuous with highly tortuous bends. The banks are well vegetated with dormant grassy slumps along the toe of the banks (**Figure 12**). The approximate channel dimensions are 30-35 ft TW, 6-8 ft BW, and 12-15 ft D. The channel and floodway in this area appear to have adequate capacity to pass the additional flows.

Figure 12. View downstream at Rd 729 access point.

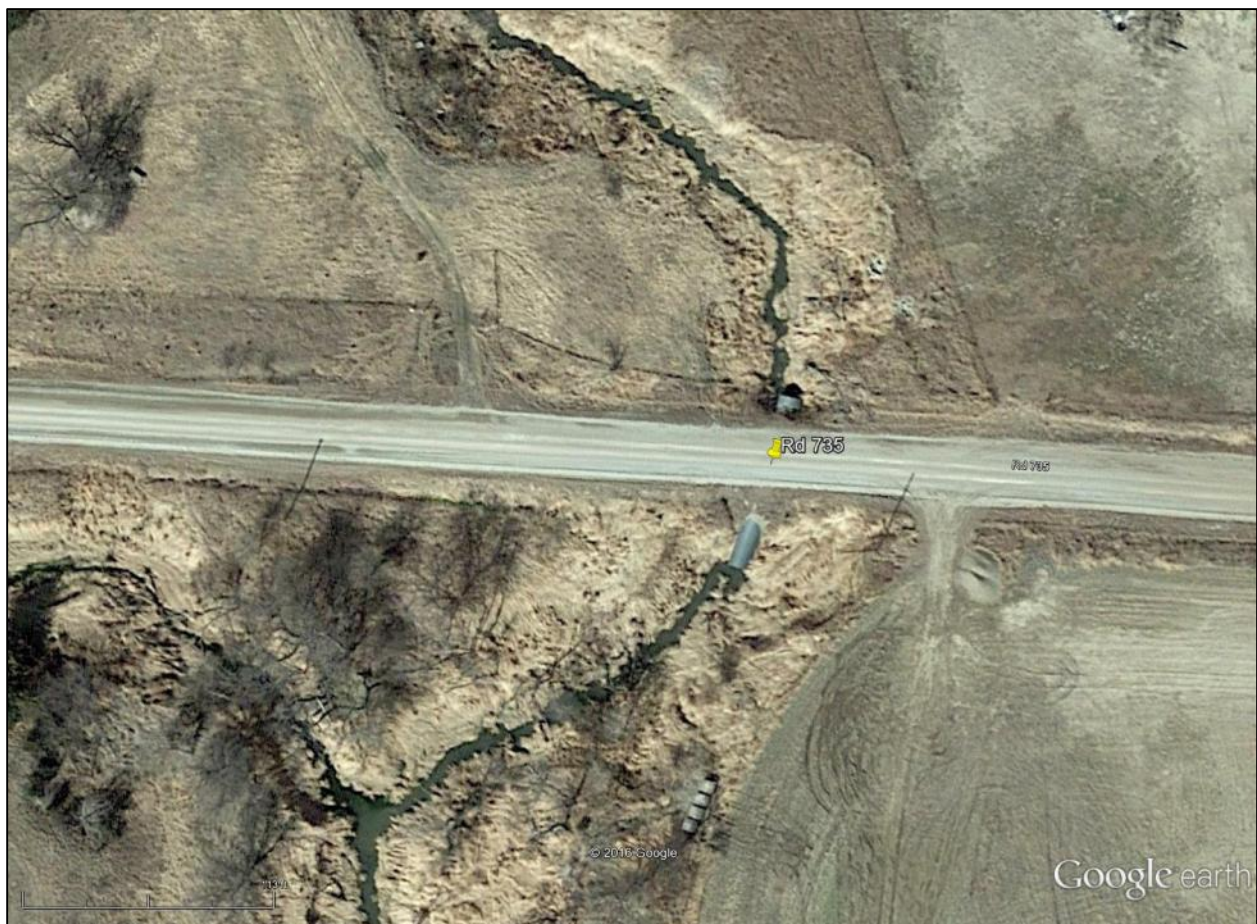
Figure 15. View of the channel and wetlands at the Rd 735 crossing.

The confluence of a right bank tributary with a fairly large drainage area intersects the creek just downstream of the Rd 735 crossing. The Rd 735 crossing is defined by a 96-inch CMP that passes under a high roadway berm (see Figure 15). The culvert has the capacity to transport the additional flows.

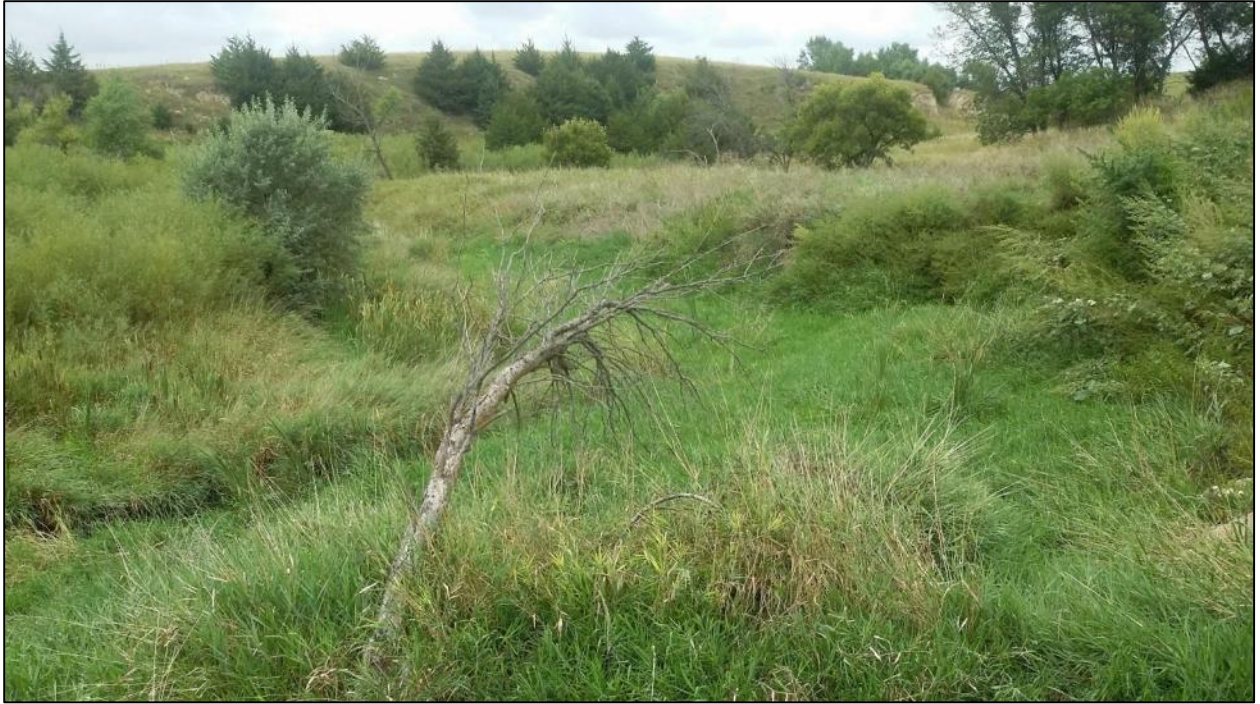
Like the previous reach, this reach had limited access and was only observed at the road crossings at the upstream and downstream ends (**Figure 16**). This reach includes the Rd 737 crossing near the upstream end. The sinuosity of the reach is fairly low and there is very little riparian vegetation along the channel. The inset floodplain/wetlands are well-developed and continuous upstream of Rd 735 as shown in **Figure 17**.

Figure 17. View looking upstream at wetlands and small inset channel upstream of the RD 735 crossing.

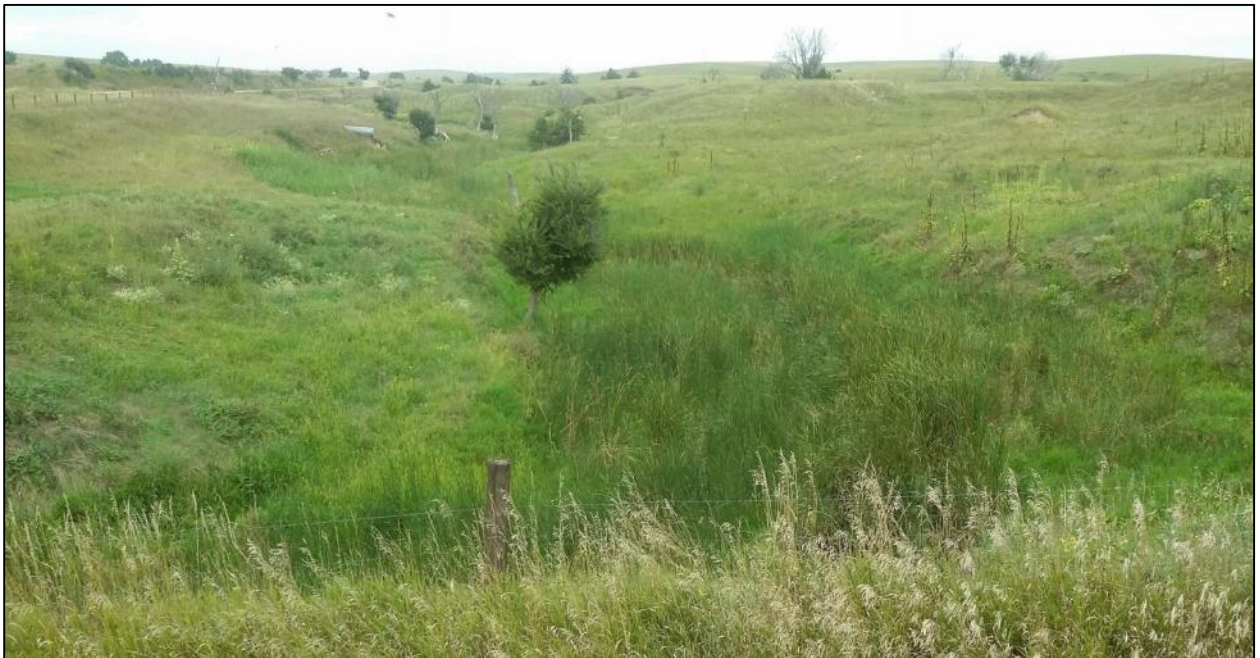
At the Rd 737 crossing, the crossing is defined by a high roadway berm over three 10-ft by 10-ft concrete box culverts with wingwalls. The channel and inset floodplain/wetlands upstream and downstream of the crossing are small. The floodplain/valley bottom width ranges from approximately 20 to 35 ft with an inset channel/wetlands depth of only about 1 foot as seen in **Figure 18**. As seen in Figure 18, there is very little woody vegetation along the channel upstream of Rd 737.

Figure 18. View looking upstream at narrow wetlands upstream of the RD 737 crossing.

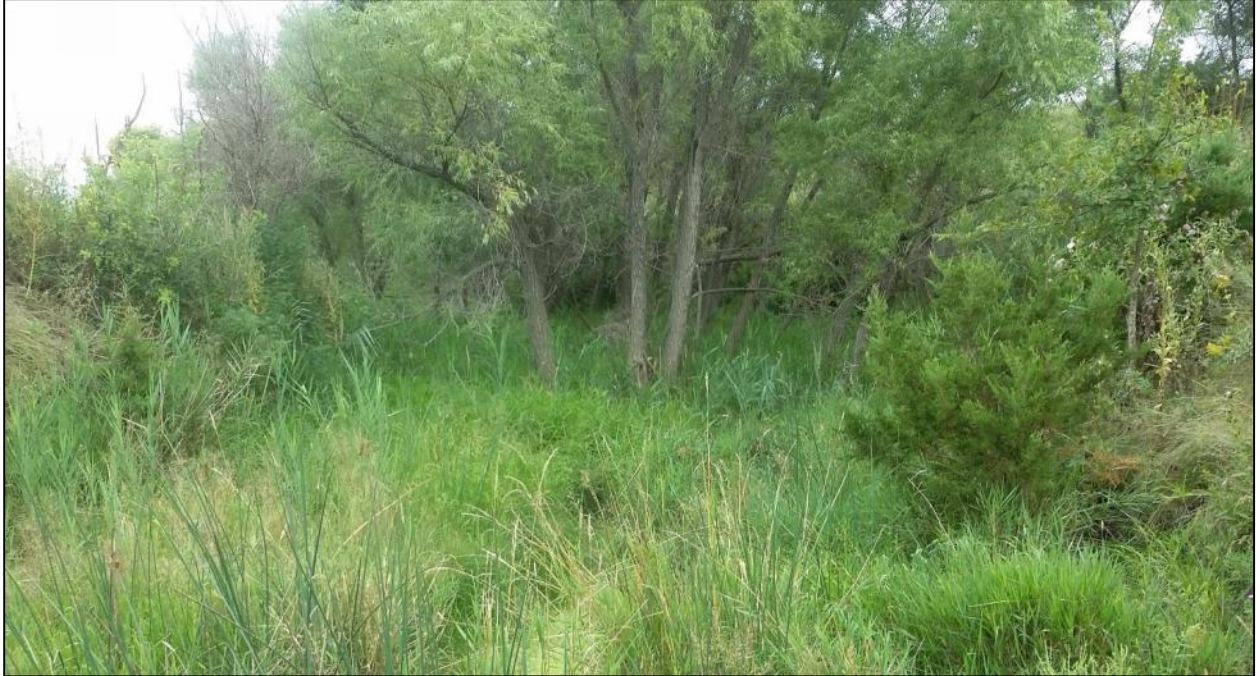
As one progresses upstream of Rd 432A, the valley bottom narrows from about 30 feet to about 20 feet and the amount of wetland flow decreases substantially. Fairly dense riparian vegetation is growing on the valley bottom for about 1,200 feet upstream of Rd 432A (**Figure 20**), at which point upstream base flow and riparian vegetation in the valley bottom disappears. From about that point upstream to the farm road, the valley bottom wetland configuration transitions from a narrow (6-8 ft BW, 30 ft TW), dry channel that is deeply entrenched (10-12 ft) in the valley floor (**Figure 21**) to a very narrow, shallow channel that disappears altogether at a small headcut just downstream of the farm road crossing. Consequently, the capacity of the channel/valley bottom to carry the additional flows decreases upstream and ends just below the farm road.

Figure 20. View looking upstream at 200 feet upstream of the Rd 432A crossing.

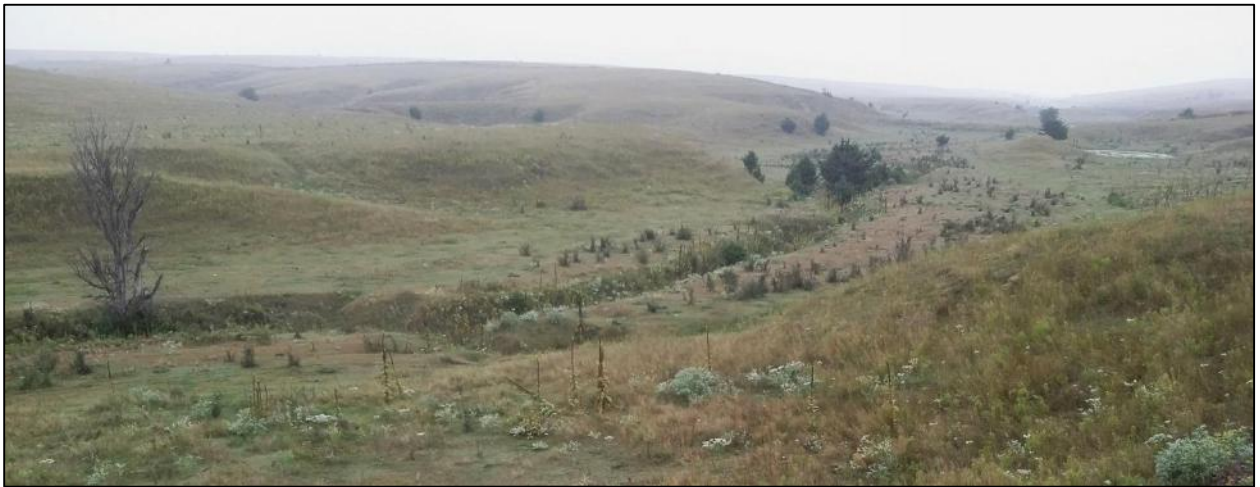
Figure 21. View looking up valley at the transition of the creek from a narrow entrenched channel to no well-defined channel just downstream of the farm road crossing.

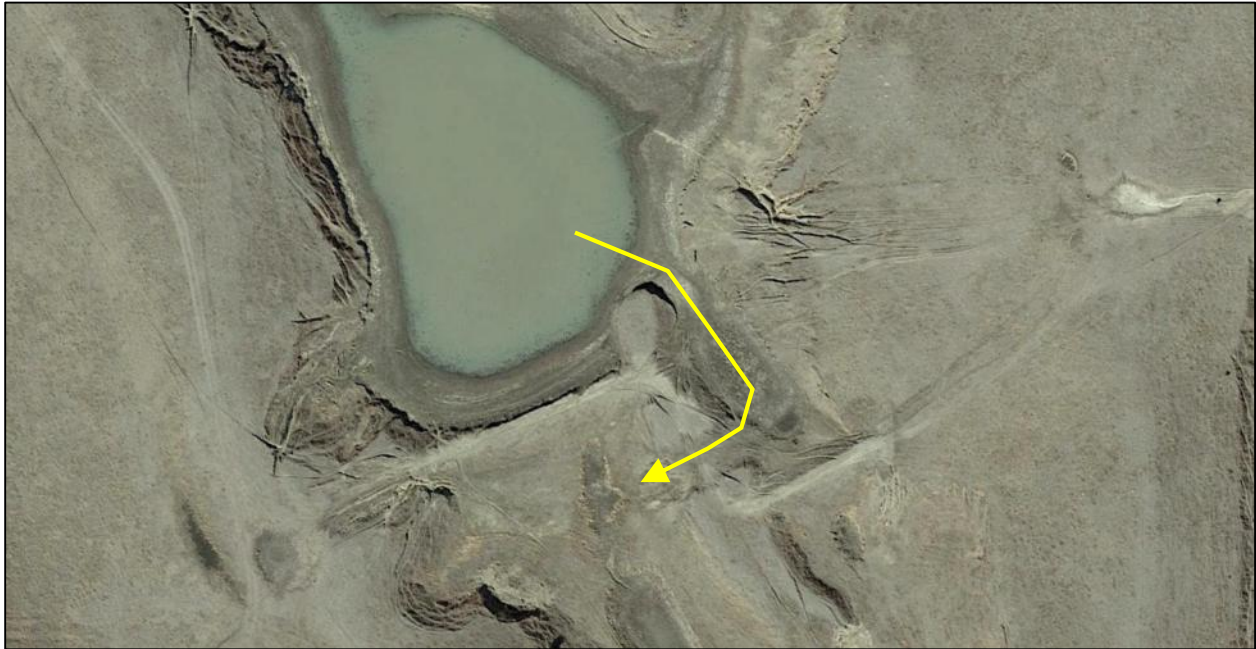
The large pond just upstream of the Farm Road (Rd 738) impounds water for almost a half mile upstream of its dam. This pond has an overflow spillway at the east end, but erosion of the upstream face of the dam threatens the stability of the dam. In addition, any supplemental flows in the future could potentially overwhelm the overflow spillway resulting in overtopping and failure of the dam.

Figure 23. View of pond, dam, and spillway (yellow line) located 1,500 feet upstream of the Farm Road (Rd 738) crossing.

There are also numerous ponds with inadequate dams that are susceptible to failure by overtopping or flanking. The dams should either be removed to prevent the potential impacts of failures on downstream facilities as well as the hazards to life and property, or be redesigned and reconstructed to industry standards with dam surface protection from cattle and wave wash, adequate pond capacity to handle the additional flows, and appropriately sized and protected overflow spillways.

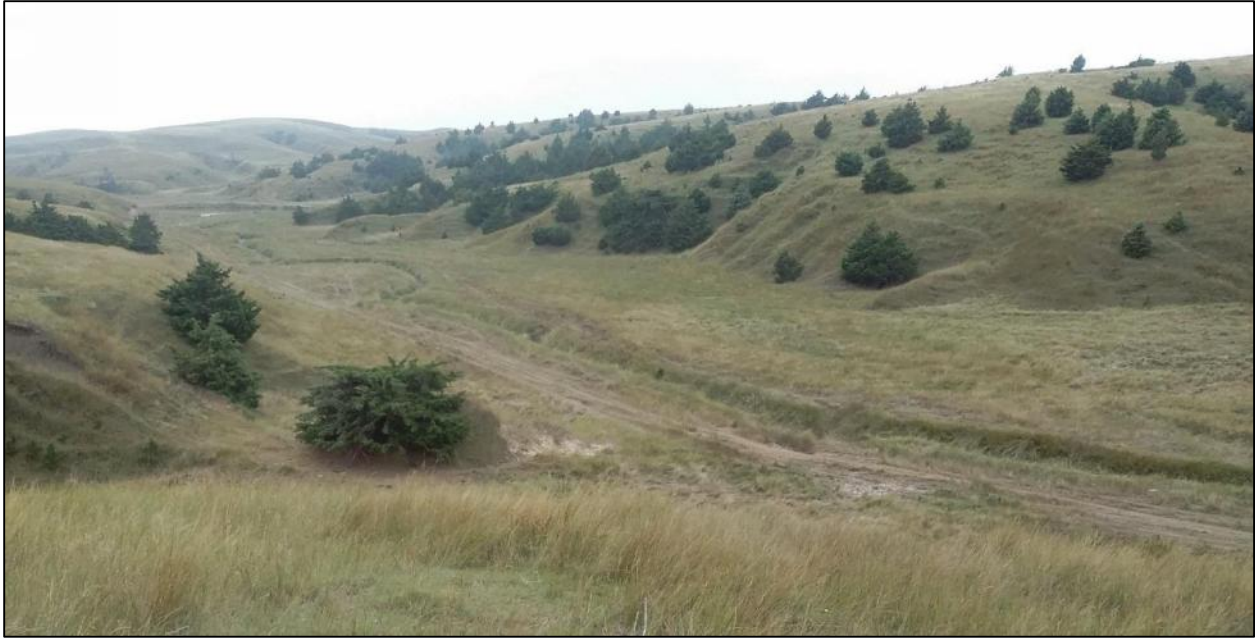
accessing the channel and getting stuck. The headcuts at the upstream end of the entrenched channel segment are about 3 to 4 feet high, but the total drop from the headcuts to a point in the channel about 100 feet downstream is about 10-12 feet. There is no defined channel in the final 3,000 feet below the diversion point.

Figure 25. View down valley showing entrenched channel segment in valley floor about 1 mile downstream of the diversion point.

for grade control. These deeply entrenched segments may also require bank stabilization or reshaping and grading of the banks to reduce the potential for significant bank erosion and failure. It is also recommended that a channel be designed and constructed in the 3,000-foot un-channeled reach below the diversion point. The constructed channel will likely require grade control and bank stabilization to maintain a stable configuration.

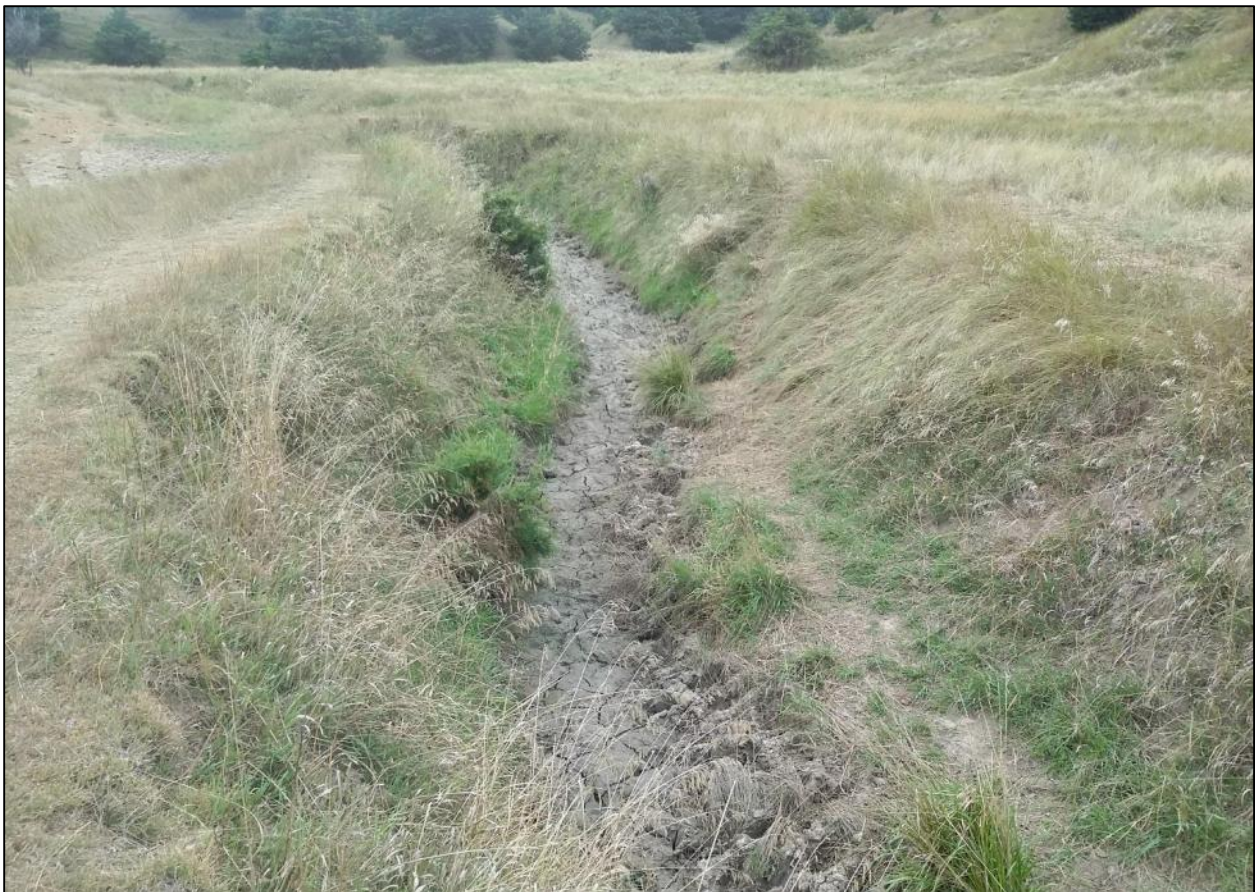
Figure 26. View downstream showing entrenched channel segment about 1 mile downstream of the diversion point. Note shallow gut channel developing in bottom in foreground.

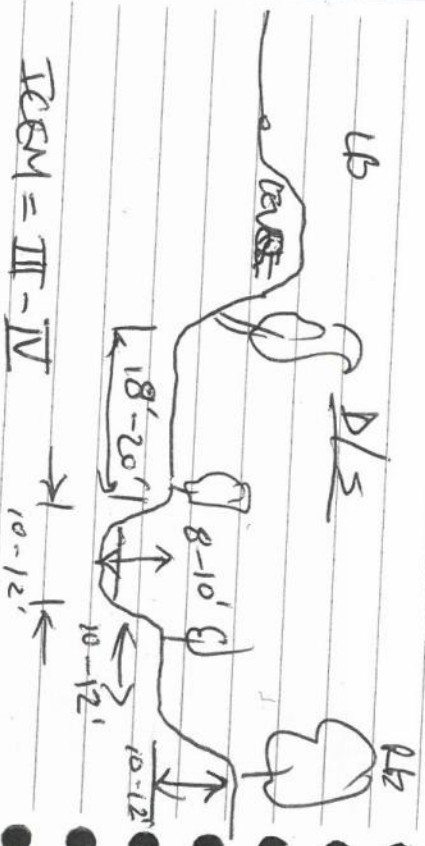
TURKEY C/C @ RD 720 ~~BRIDGE~~

- LEAVES ON D/S LB SAND ON W/S RB.
- SECONDARY INCLUSION EVENT DOCUMENTED IN CROSS SECTION

ICSM = III-IV

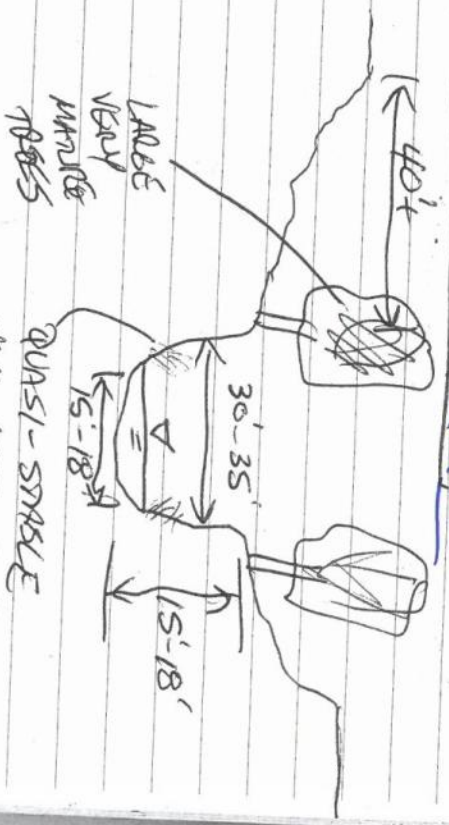
8/30/2016 - overcast, breezy
TURKEY @ RD ~~720~~ 722

- CHANNEL IS DEEP LY ENTRENCHED BUT STABLE w/ DENSELY VEGETATED BANKS
- BANKS ARE RELATIVELY SPOSS BUT HAVE VEG. ON MESH w/ VEGETATION TREES ON TOP
- DEPRESSIONAL BEHIND THE OF BANK
- BULGE IS OLD BUT ASSSES FLOW → HAS SEDIMENT DEPOSITED ON TOP.
- WOODY DEBRIS IN CHANNEL

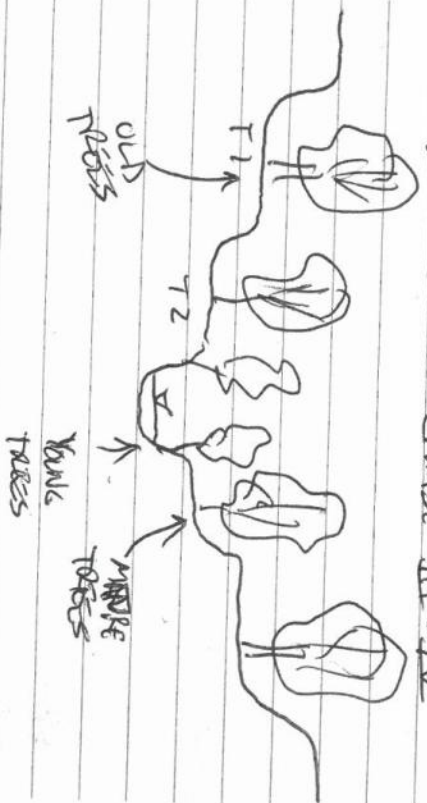
TURKEY @ HWY 6/34 BRIDGES

- BIG BRIDGE w/ PLenty of CAPACITY
- 1/5 CHANNEL IS SMALLER BUT HAVE 2 SETS OF BRIDGES/TRAFFICS = 2
- * MASONRY STRUCTS (PHASE III-IV)

- CHANNEL HAS 8-12' SW
- 12-15' TD, ~ 8-10' DEPTH
- TRAILHEADS = T1 = 15'-12' WIDE
- T1 = 30-40' WIDE

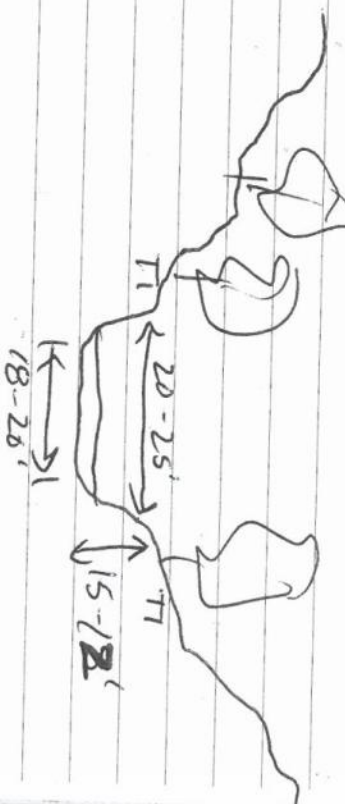
TURKEY @ RD 432 BRIDGE

- HARD TO TELL IF HAVE T2 TRAFFIC, STILL HAVE T1
- CHANNEL IS WIDER D/S OF BRIDGE

- VERY POOR VEG, DEBRIS IN CHANNEL
- CAPACITY IS REDUCED COMPARED TD D/S
- REMnants (INTERMEDIATE) OF T2 1/5? HARD TO TELL

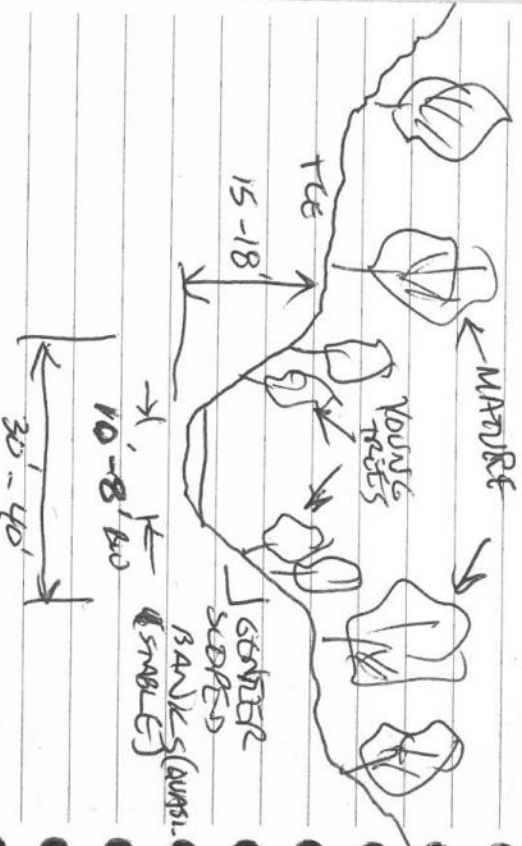
TURKEY @ RD #431 BRIDGE

- GRASS INTD THUS
- CHANNEL IS DEEPLY
- SUBMERGED w/ HIGH TCS

- NARROWER BRIDGE CAPACITY
- but SNL HAVE PLENTY

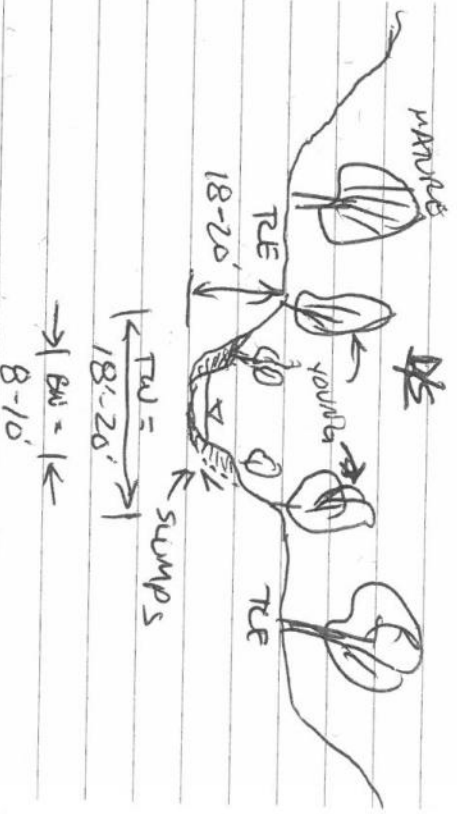
TURKEY @ RD #726 BRIDGE

- CHANNEL IS NARROWER w/
- REMANANTS of DOMINANT BANK
- SUMPS
- HIGH TCE ON BOTH BANK

- BEAMS AT LOWER BANK
- APPEAR TO BE DOMINANT
- SUMPS, OTHER SPOTS ARE
- ACTIVE
- LIQUIDATED SWAMP IN RB JUST
- D/S OF BRIDGE!
- W/S HAVE TRENCHES BUT NOT AS
- DOMINANT
- SMALLER BRIDGE HSLE

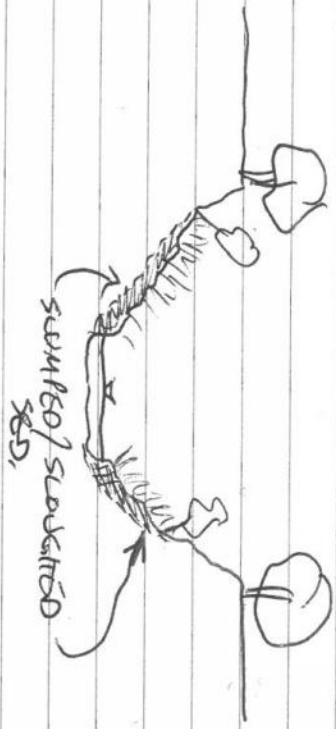
TURKEY @ BUD @ RD # 729

- FLOW IS SLOWER → MENDOTA
- WELL VEG' @ BANKS w/ DURANT SWAMP

- BUD = 6'-8'
 TW = 30'-35'
 DEPTH = 12'-15'

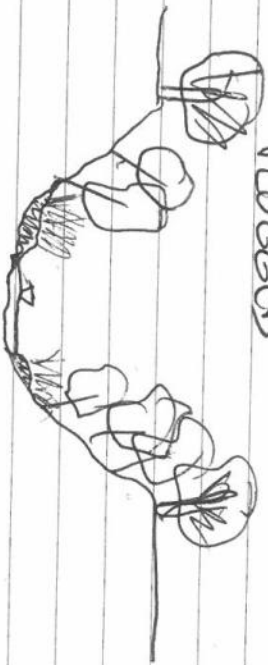
TURKEY @ RD # 432 CURB

The Rd 432 crossing is composed of a 60-inch CMP with a sheet pile headwall and rock riprap at the upstream end. No protection is evident at the downstream end of the culvert. The upstream end is partially blocked by woody debris, which is significantly reducing the capacity of the culvert. Given the potential for large woody material fully blocking the upstream end of the culvert, backwater and overtopping of the roadway here is highly likely. Under current conditions at this crossing, additional flows may exacerbate the potential for roadway overtopping.

- PILE HAS 60" CWP UNDER ROAD
- W/S SIDE OF CURB HAS SIBBY PILE HEADWAY → CURB IS PRETTY BROAD WITH DEBRIS
- W/S OF CHANNEL IS ENTRENCHED
- BW = 6'-8'
- TW = 25'-30'
- DPTH = 12'-15'
- NO CAPACITY HERE, HIGH FLOWS MAY BACK UP & OVER TOP ROAD, ESP. IF CURB GETS RUGGED

In general, the creek between its confluence and Rd 432A is stable and its channel and floodway appear to have sufficient capacity to carry the additional diverted flows. However, some crossing structures, such as the CMP at Rd 432, may not have sufficient capacity to carry the additional flows and may need to be replaced.

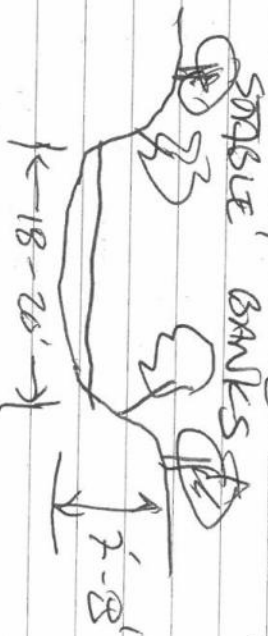
DRIVE AWAY TO RIVER AREA

- DOUBLE CWP (48") w/ ROCK FILL & CONCRETE END ON ROAD
- CURBS ARE LOW SO HIGHER FLOWS PROBABLY DRIP TOP ROAD, ESP. IF CURBS GET BLECTED
- D/S CHANNEL 15.15'-18' WIDE w/ 7'-8' DPTH & SOFT BANKS
- TOP OF ROAD @ CURBS IS 1'-2' LOWER THAN F/P SURFACE
- CURBS DO NOT HAVE SUFFICIENT CAPACITY

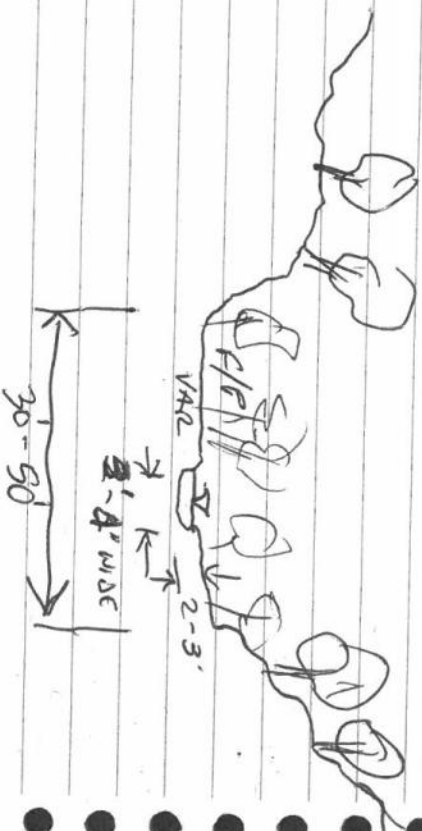
TRUCKY @ PD # 735 CURSOT

- CURSOT IS 84" OR 96" CAMP.
- W/S & D/S CHANNELS ARE SMALL → 2'-4' WIDE 2-3' DEEP w/ LOW INSET BANKS

- CURSOT MAY HAVE SURFICENT CAPACITY BENDING ON OTHER FLOWS
- HAVE 2 LARGE TRIBS COME IN 2-3 MILES D/S SO LOSE A LOT OF FLOW UP HERE

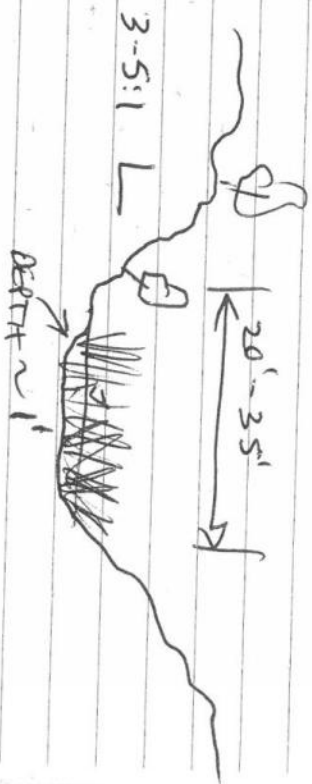
TRUCKY @ PD # 737 CURSOT

- CROSSING IS 3X10' X 10' BOX CURSOTS w/ WINDWATERS
- W/S & D/S CHANNELS IS WSTRANDS

- INTERSPERSED DEAD TREES W/S
- MOD. DENSE LIV TREES D/S

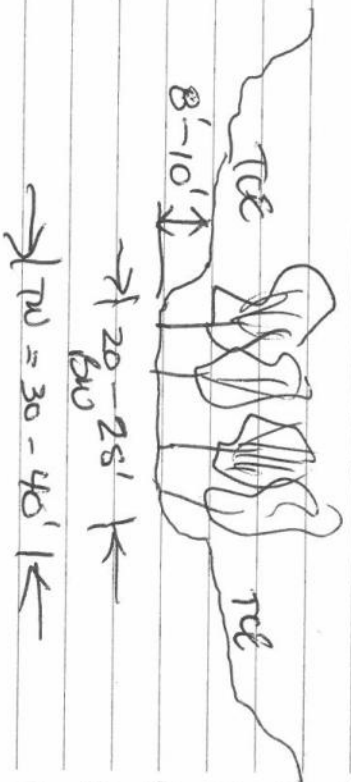
TURKEY CRT @ RD 432A

- CROSSING IS SHEET PILE BOX w/ WINKLUMUS
- WEST CHANNELS W/S \neq D/S
- D/S CHANNEL HAS 20-25' BUW \neq 30'-35' TW \rightarrow 8'-10' DEEP
- W/S SAME WP TO END OF SYNCHRONIT WHARF \rightarrow ABOUT LARGE DIAM, DEEP UNBUNDLED IN BOTTOM IN MIDDLE
- W/S TO FRONT ROAD LOCAL WATER X-ING \rightarrow 30" CAMP
- \rightarrow W/S \neq D/S HAVE SAME AGE BRUSH TREES GROWING IN BOTTOM OF CHANNEL

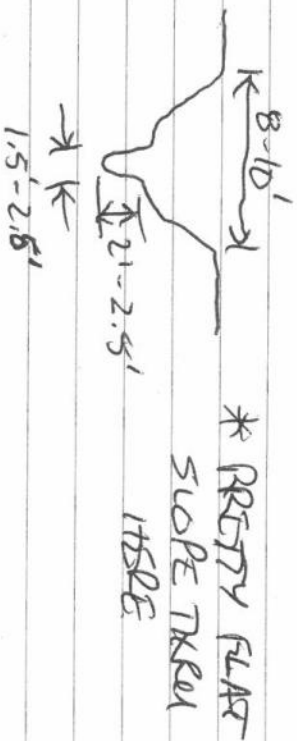
TURKEY CK NEAR 1/5 END

- PAVED AND UNPAVED DAM
- RESTRICTOR/POND D/S
- CHANNEL IS PRIMARILY MAINTAINED BY SPREADERS SUPPLIES & CARTS

- NOT SUFFICIENT CAPACITY TO CARRY 40 CFS
